**Table 7.1 Summary Ratings of Surveyed Infrastructure
- East Carolina University -**

This table above summarizes the OVERALL Risk Rating for 10 campus facilities on the date in 2010 that it was inspected, and at some future, unspecified time by which all recommended Mitigation Actions have been completed. Each facility report section provides the data resulting from the on-site engineering inspection, plus the risk calculations that resulted from applying the UFRAS software. Data from all 10 facility inspections and UFRAS calculations will be contained in an accompanying CD.

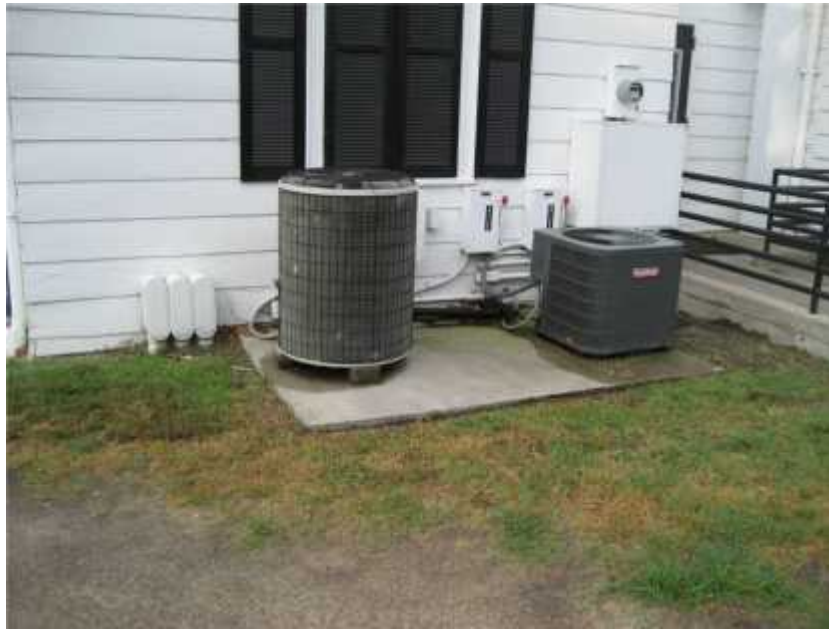
- Some of the heat pumps are not anchored to their foundation and the minisplit heat pumps have only partial anchorage. The emergency generator is not anchored to its foundation. (Photos 1 and 2)
- The windows in the dispatch area are unreinforced against wind-borne debris impact. (Photo 3)
- The basement sump pump is undersized relative to the rate of water infiltration during intense storms.
- There is only one direct fiber optic link with Joyner East. If this line were severed, there would be a significant disruption to VOIP and data services.
- The room designated as the EOC is too small to house even a partially staffed EOC. The room also has several unreinforced windows. (Photo 4)
- The dispatch area is too small to allow consolidation of the primary and Brody Hall 911 call centers.
- The dispatch area is not protected against accidental vehicle strikes on its eastern facade.

Photo 1. View of heat pumps not anchored to their foundation. Heat pumps and minisplits should be properly anchored to their foundations.

- All HVAC equipment should be properly anchored to its foundation. **A** (Wind/Hurricane, Tornado)
- The generator should be properly anchored to its foundation. **A** (Wind/Hurricane, Tornado)

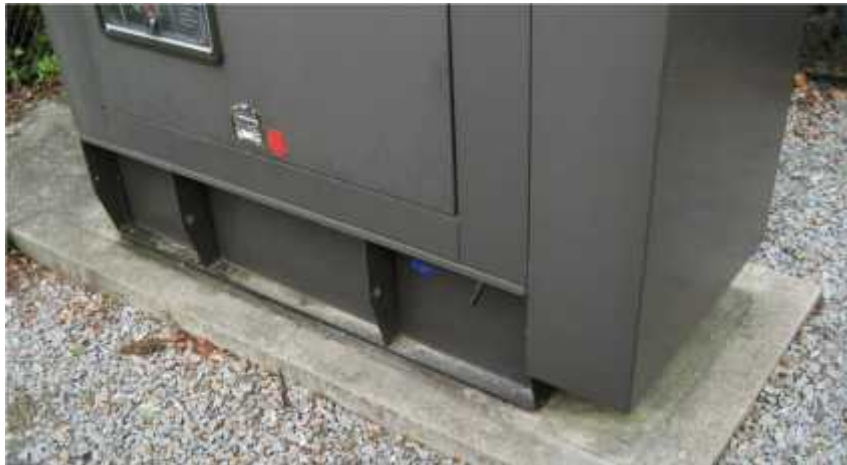
Photo 2. View of emergency generator. The generator (and the new unit in planning) should be properly anchored to its foundation.

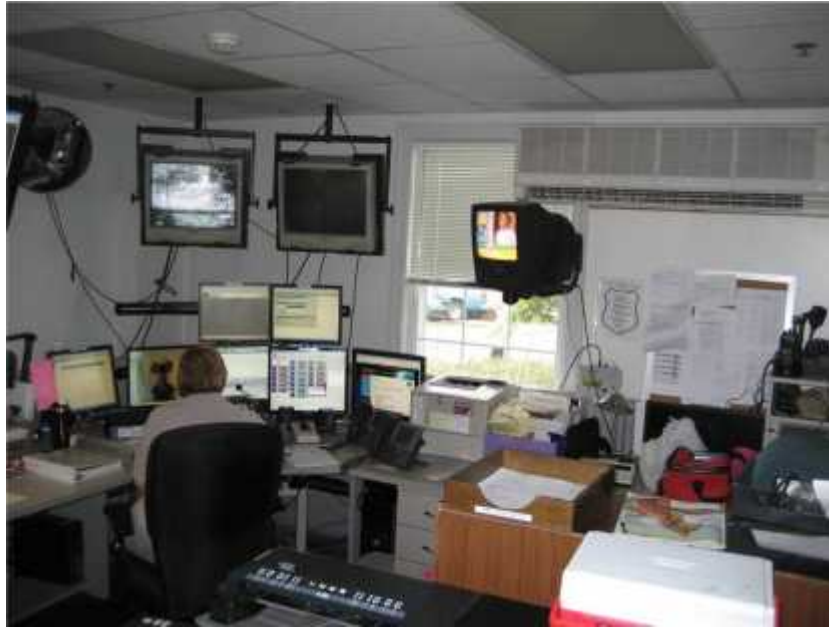
Photo 3. View of unreinforced window in dispatch area. Dispatch area is too small to accommodate consolidation of Brody 911 call center which would be beneficial to disaster response due to technological/logistical considerations.

- The windows in the dispatch area should be reinforced to prevent shattering as a result of wind-borne debris impact. **A** (Flood)
- A secondary or single large sump pump should be installed in the basement to prevent flooding. **A** (Flood)

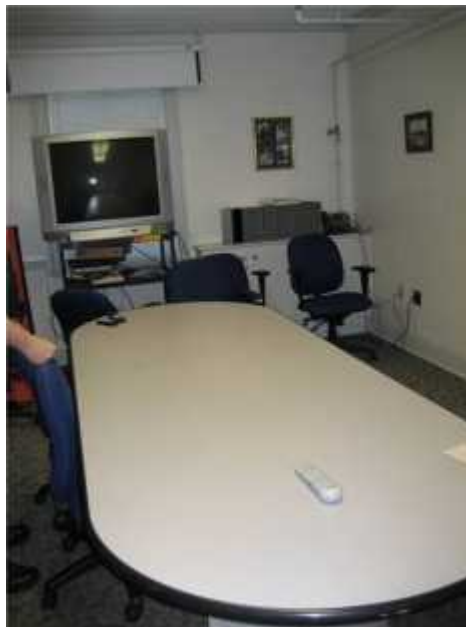
Photo 4. View of the EOC at the Blount House. The room is too small to house a fully staffed EOC and has several unreinforced windows.

- The EOC should be relocated to another facility to allow a fully staffed EOC to meet in a single location. The 911 call/dispatch centers from Blount and Brody should be consolidated into this new facility. **D** (All hazards)

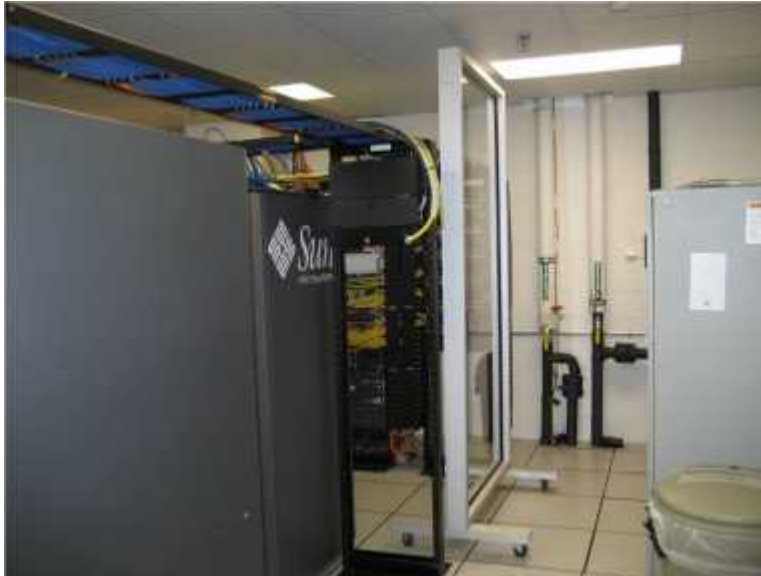
Photo 1. View of water lines in hot-site data center. Leibert unit at right uses potable water for heat rejection during power outages. Drain lines for this water are undersized and could flood the room.

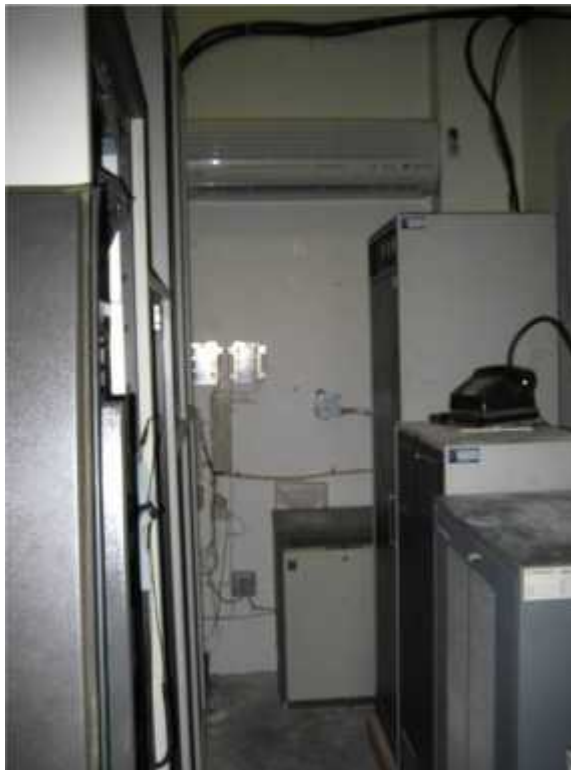
Photo 2. View of critical radio equipment in penthouse closet. The two radio rooms need smokeheads and temperature sensors.

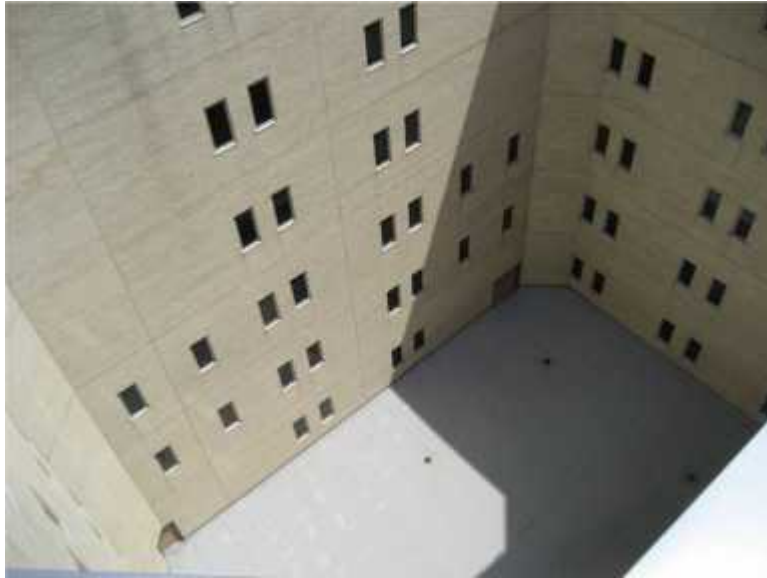
Photo 3. View of façade of interior courtyard. Several areas of the façade are reported to leak water in driving rain as a result of both improper construction and a failed remediation attempt.

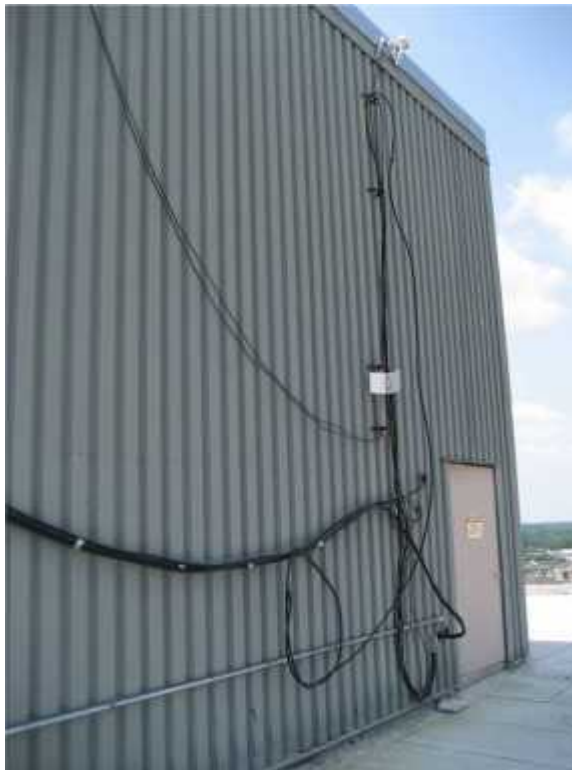
Photo 4. There are loose antennae cables attached to the outside of the mechanical penthouse. The cables should be better anchored to prevent damage in high winds.

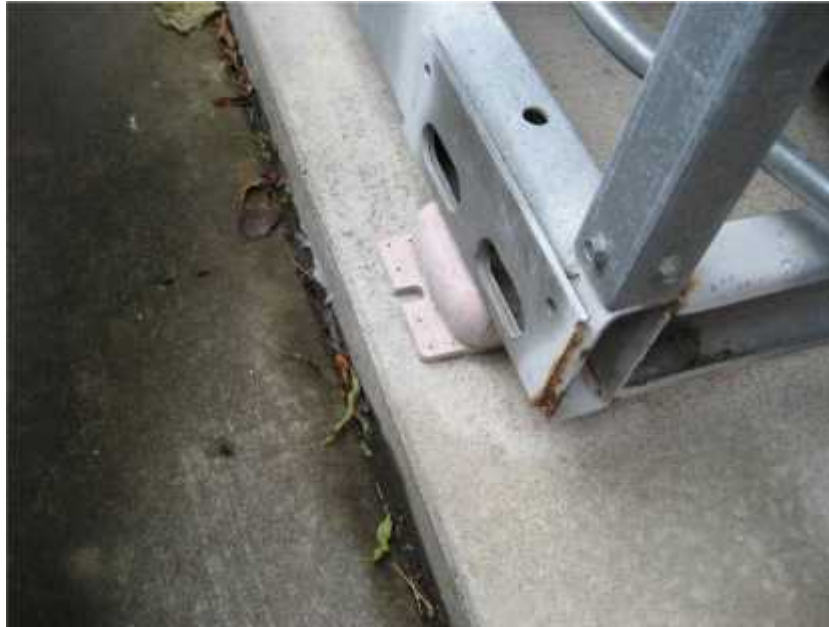
Photo 1. View of chillers at northeast corner of facility. Mechanical equipment should be properly anchored to their foundations.

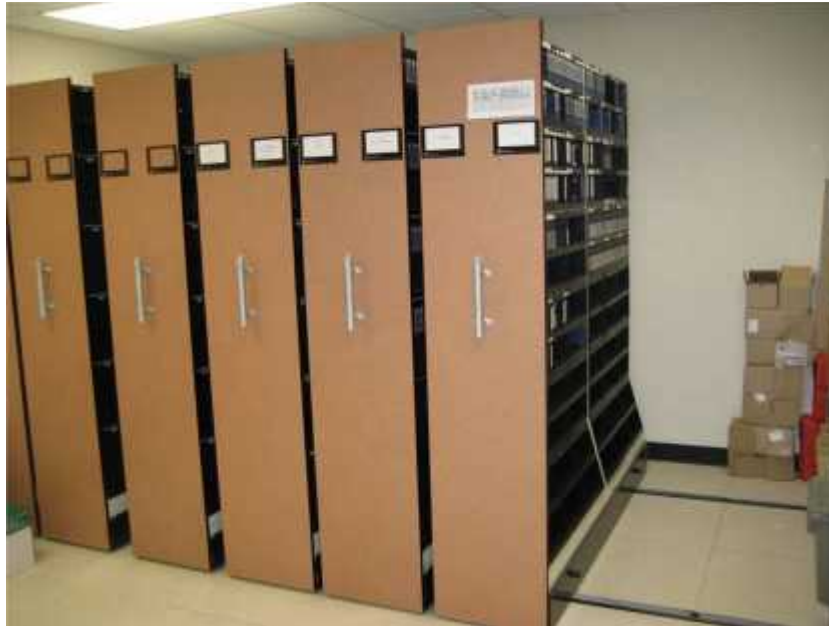
Photo 2. View of tape storage racks located in the same building as the primary data center. It is inadvisable to maintain the primary copy and the backup copy in the same location, even considering the hot-site data center in Brody.

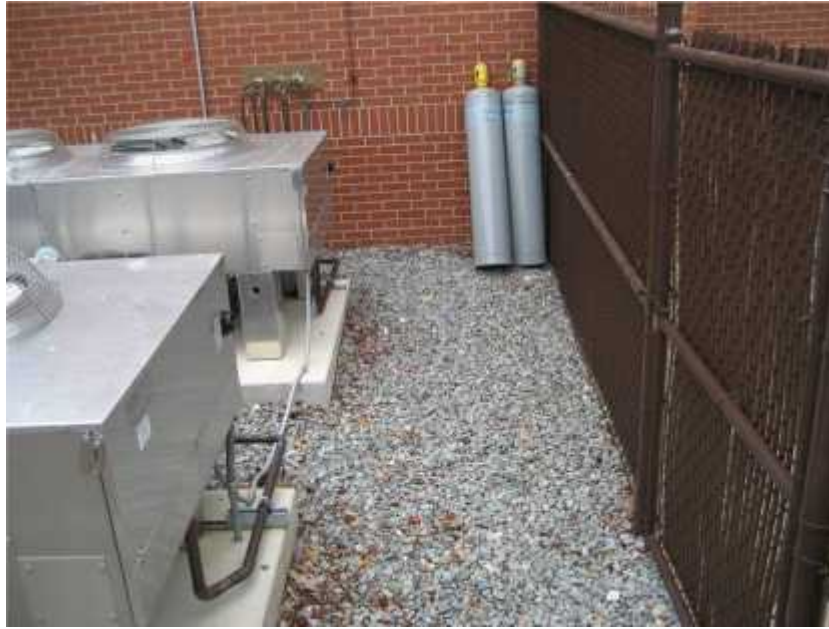
Photo 3. View of gas cylinders leaning against the southeastern exterior wall of the facility. Gas cylinders should be anchored to the wall, regardless of contents.

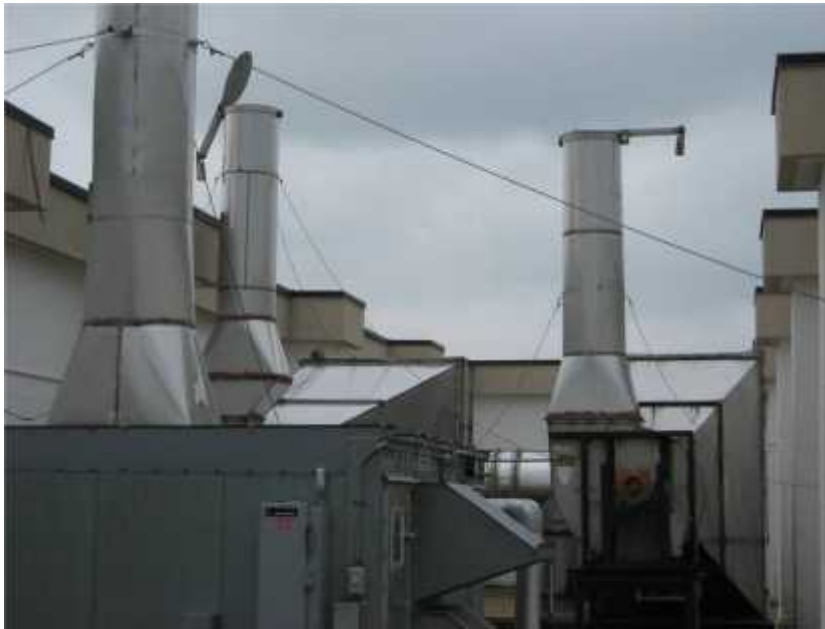
Photo 1. View of exhaust vents for BSL level 3 lab. Guide wires should be tensioned to prevent wind damage to exhaust stacks.

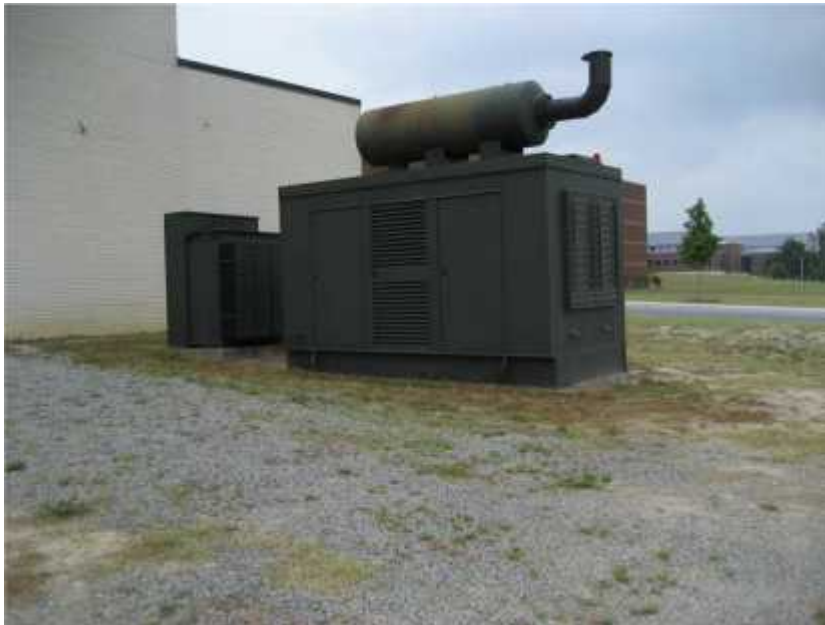
Photo 2. View of emergency generator. Mechanical equipment serving critical facilities should be anchored to its foundation.

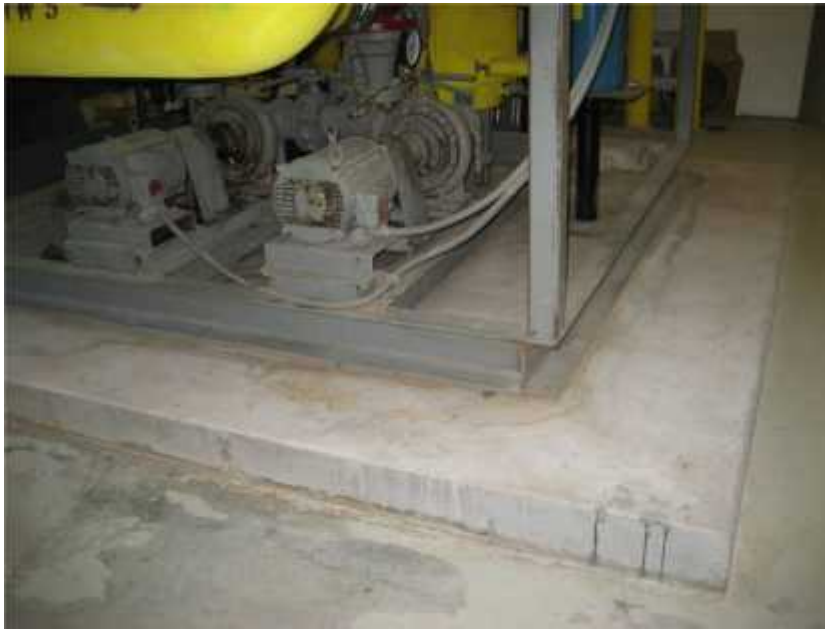
Photo 3. View of coolant/condensate pump skid not anchored to foundation. Mechanical equipment serving critical facilities should be anchored to its foundation.

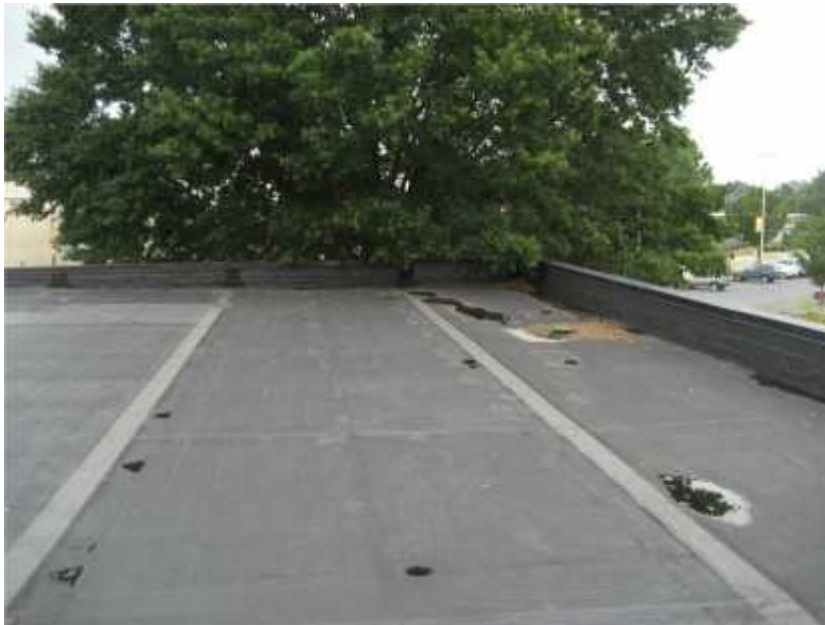
Photo 4. View of tree overhanging roof at northeast corner of facility. Trees should be pruned to reduce the likelihood of clogging roof drains.

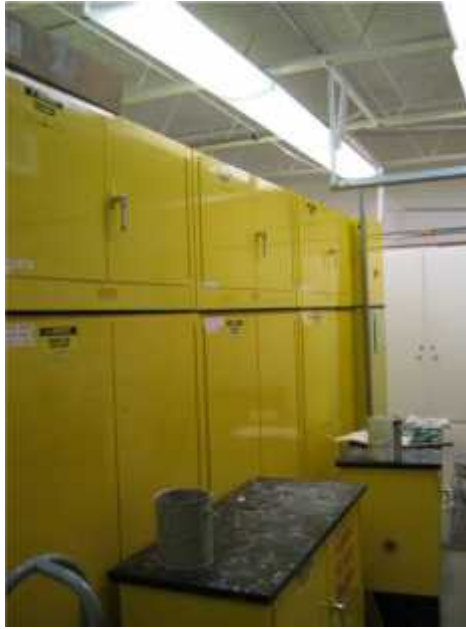
Photo 1. View of flammable storage lockers in paint shop. This area of the facility has neither fire detection or suppression systems.

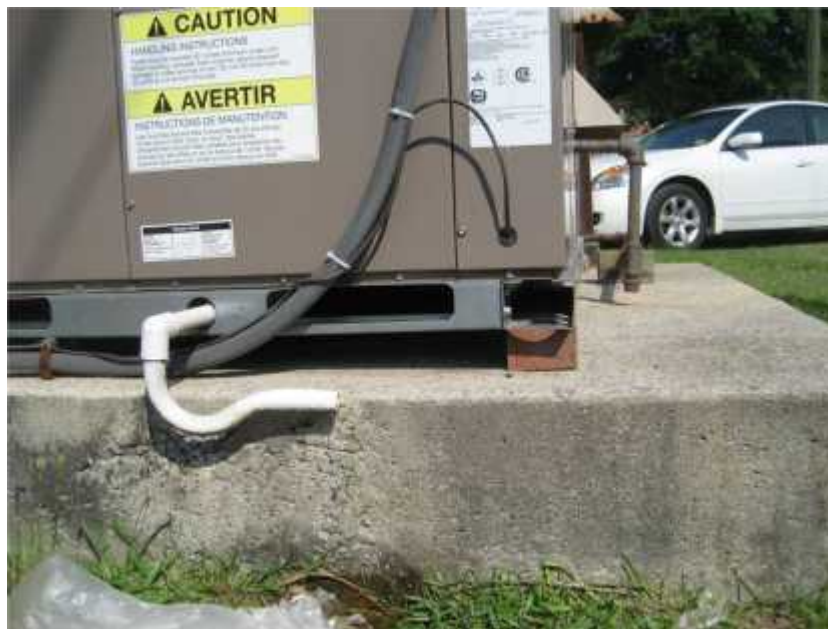
Photo 2. View of pad mounted HVAC equipment at the rear of Eppes #3. All mechanical equipment should be properly anchored to its foundation.

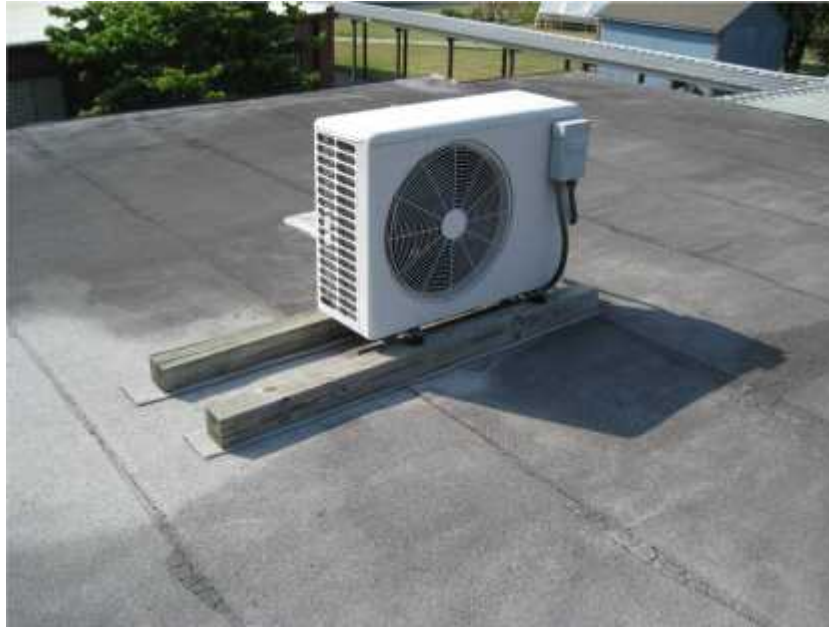
Photo 3. View of roof mounted minisplit heat pump showing supporting timbers oriented in least stable configuration. Minisplit units should be anchored to the structure.

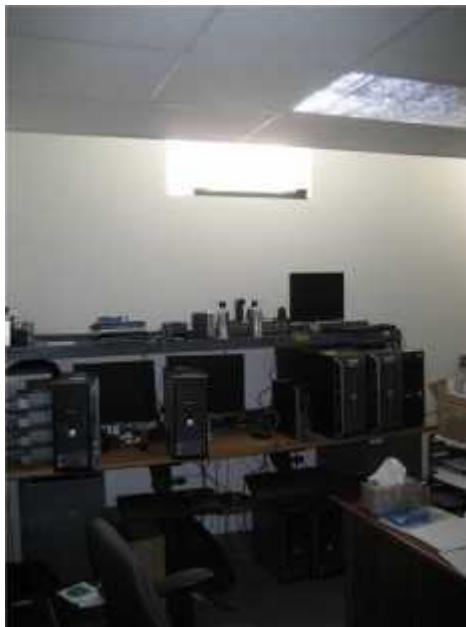
Photo 4. View of facilities management servers located in Eppes #3. If the window above the equipment were to break during a severe storm, driving rain could damage or destroy the servers.

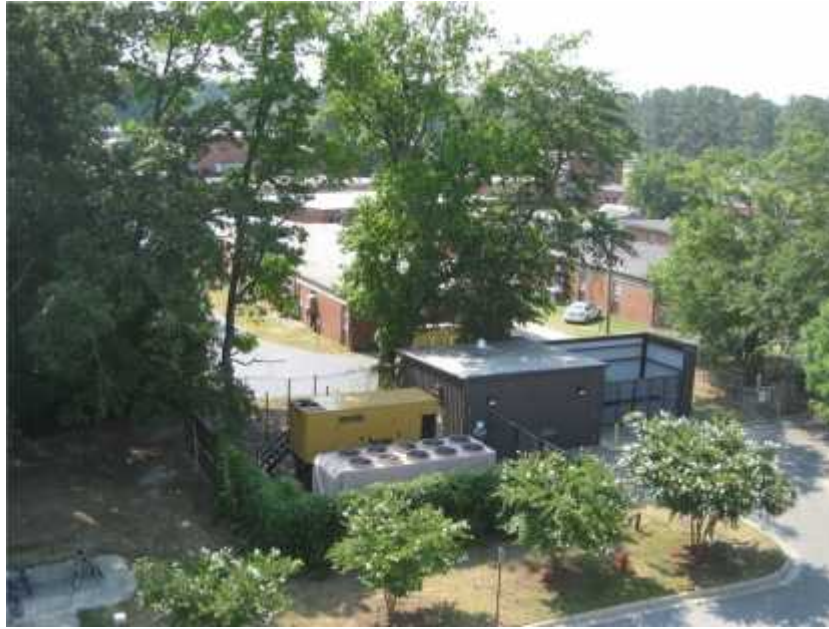
Photo 1. View of large trees overhanging emergency generator and chiller. Trees should be routinely inspected and pruned by an arborist to mitigate the potential for wind related damage.

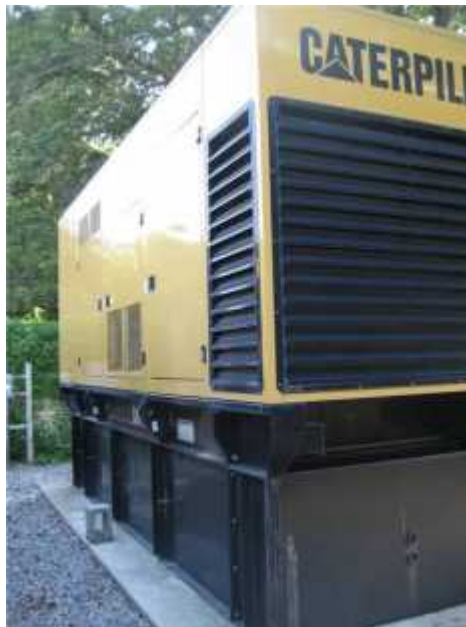
Photo 2. View of the emergency generator. The generator should be properly anchored to its foundation.

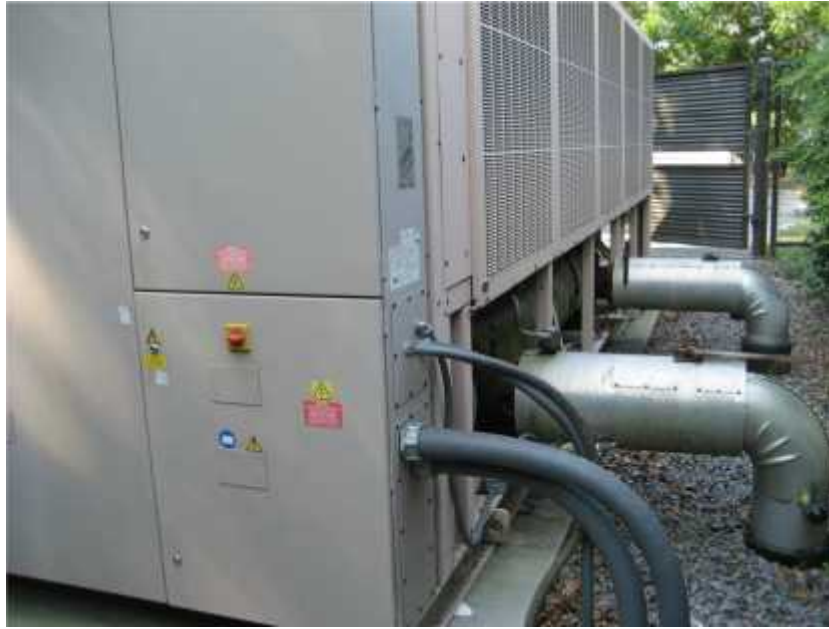
Photo 3. View of the chiller on its skid. The chiller should be properly anchored to its foundation.

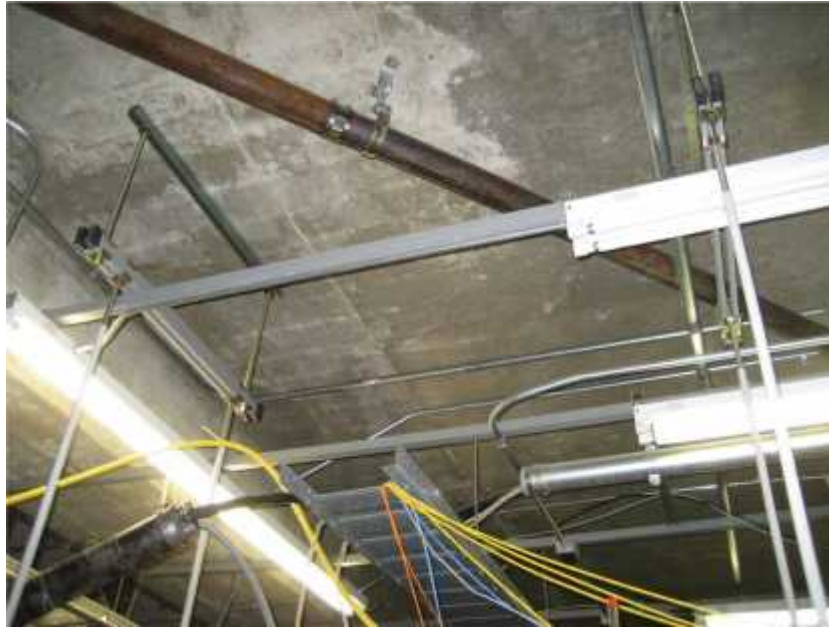
Photo 1. View of roof drain lines suspended over sensitive network equipment. Provide an alternate catchment system, such as a gutter, to prevent damage to electronic equipment.

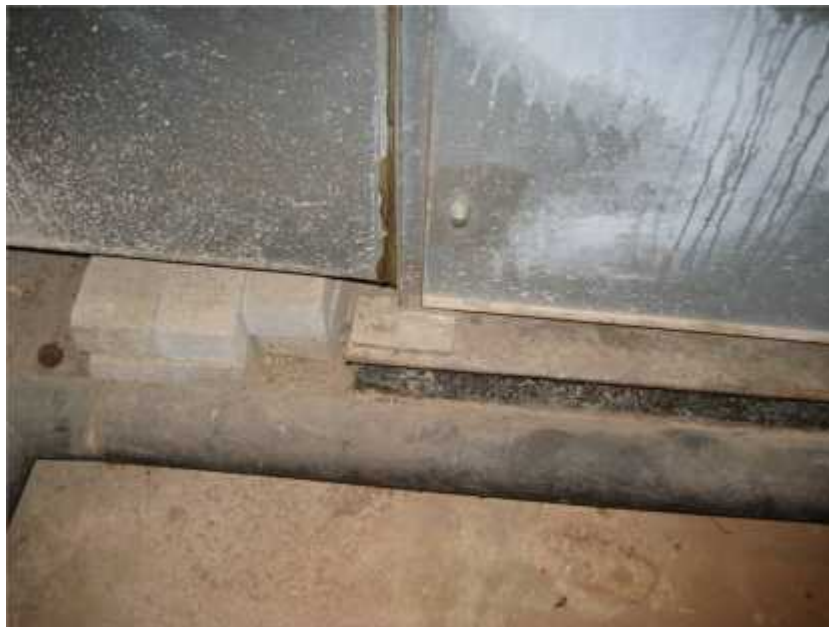
Photo 2. View of anchorage point for air handling unit for network area. The air handling unit should be anchored to its foundation.

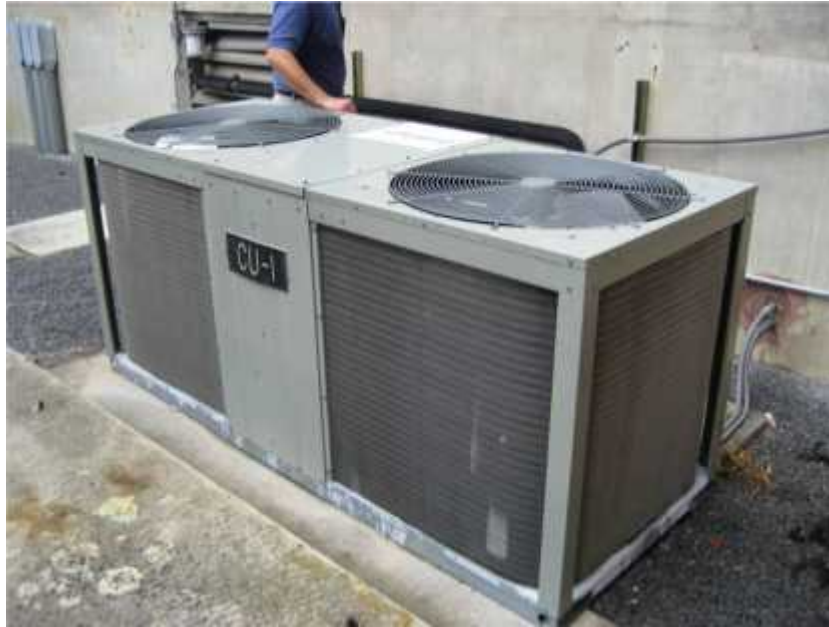
Photo 3. View of the compressor unit for the network area. The unit should be anchored to its foundation.

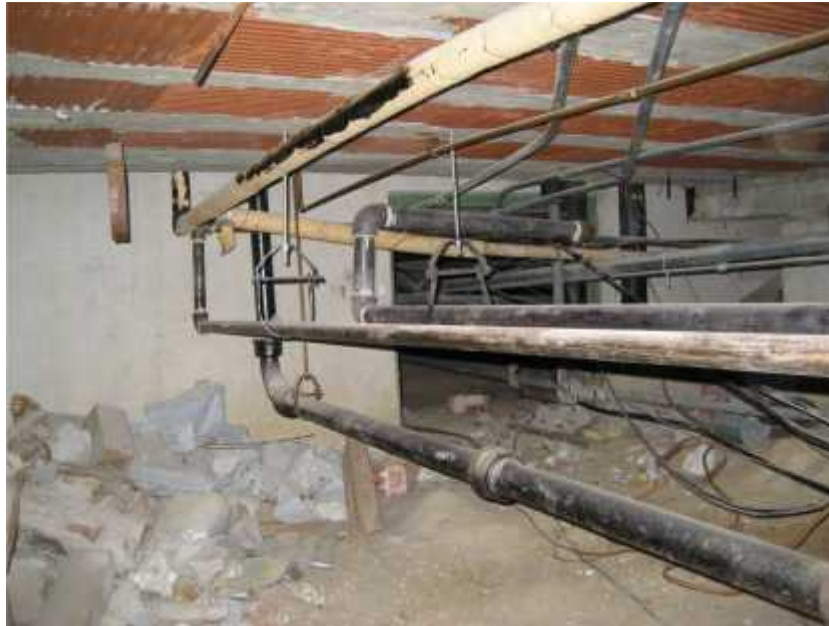
Photo 4. View of water pipes in crawlspace adjacent to network area. This area should have a water monitoring system to detect pipe leaks to prevent potential network gear damage.

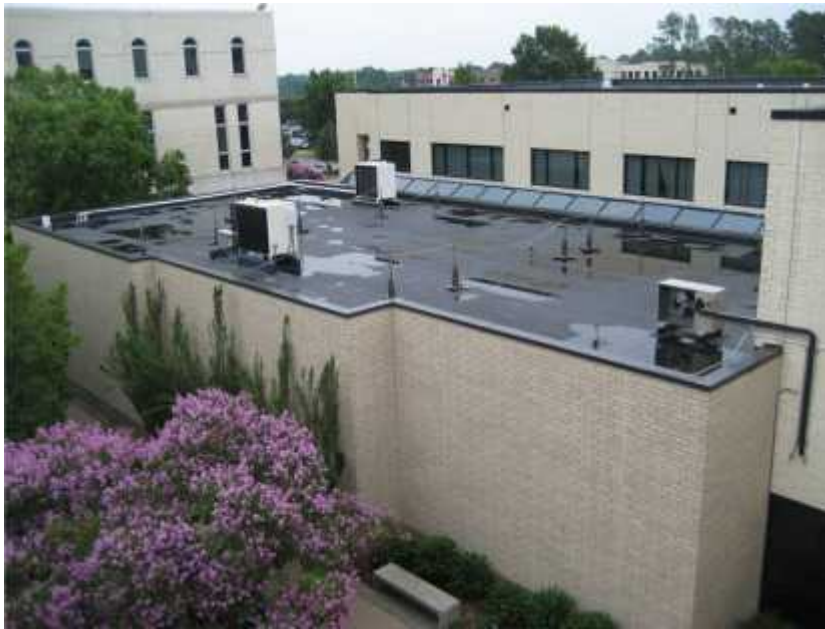
Photo 1. View of radiation treatment area of the building. The equipment inside the building and the supplemental cooling (visible on roof) do not have emergency power.

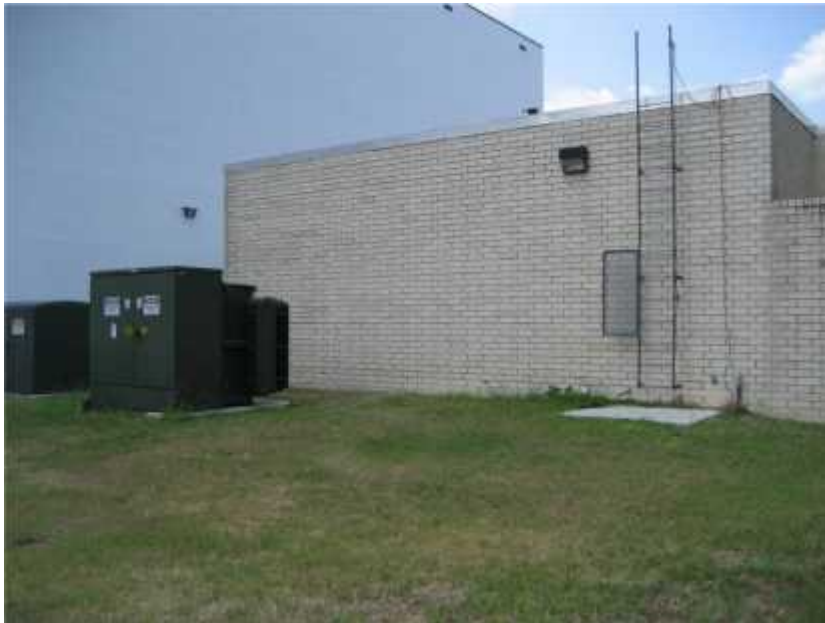
Photo 2. View of Brody emergency generator facility. The lines connecting this building to Leo Jenkins are undersized relative to available emergency power.

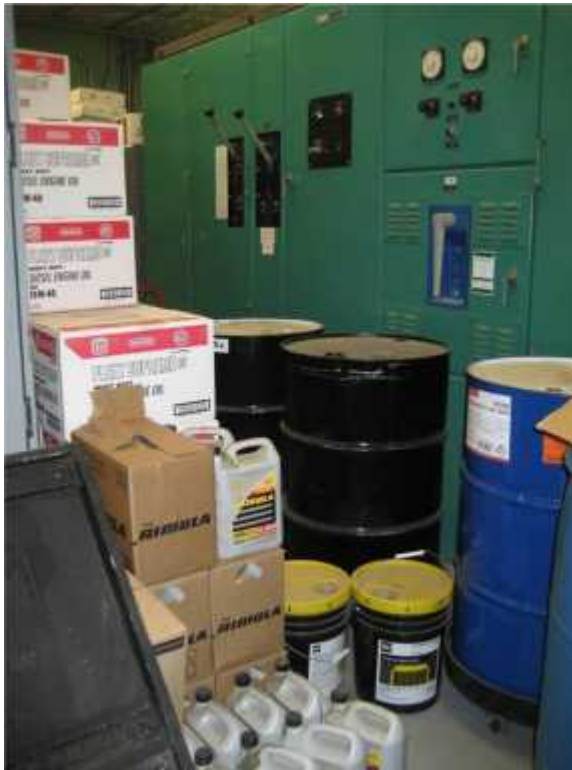
Photo 3. View of combustible materials impeding on equipment clearances. Materials should be stored in an alternate location, in accordance with code requirements.

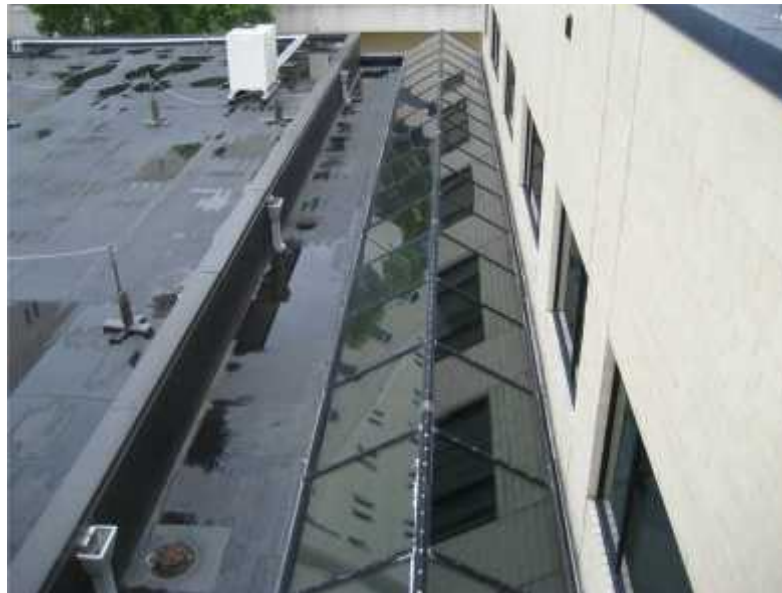
Photo 4. View of skylights over radiation therapy treatment staging area. Skylights are reported to leak during intense storms.

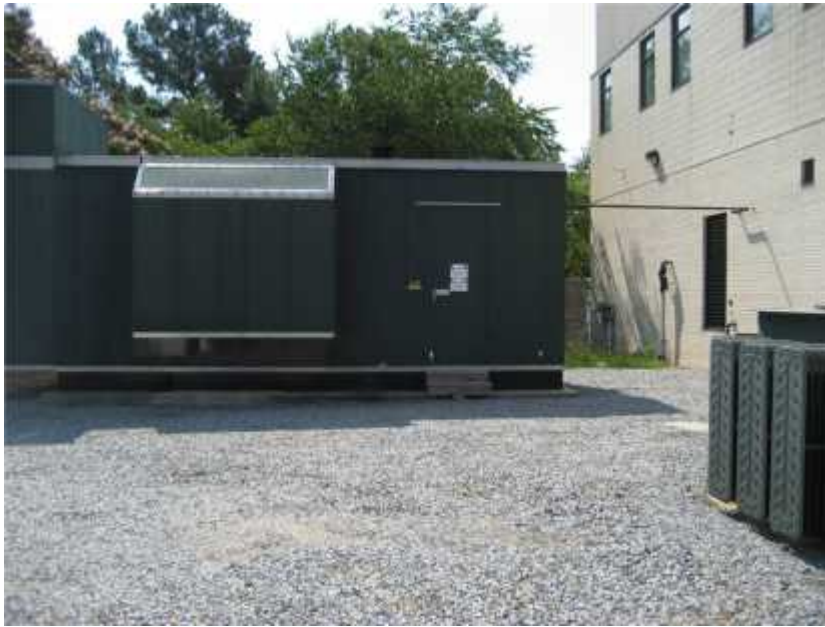
Photo 1. View of the emergency generator. Mechanical equipment supporting critical facilities should be anchored to its foundation in compliance with the building code.

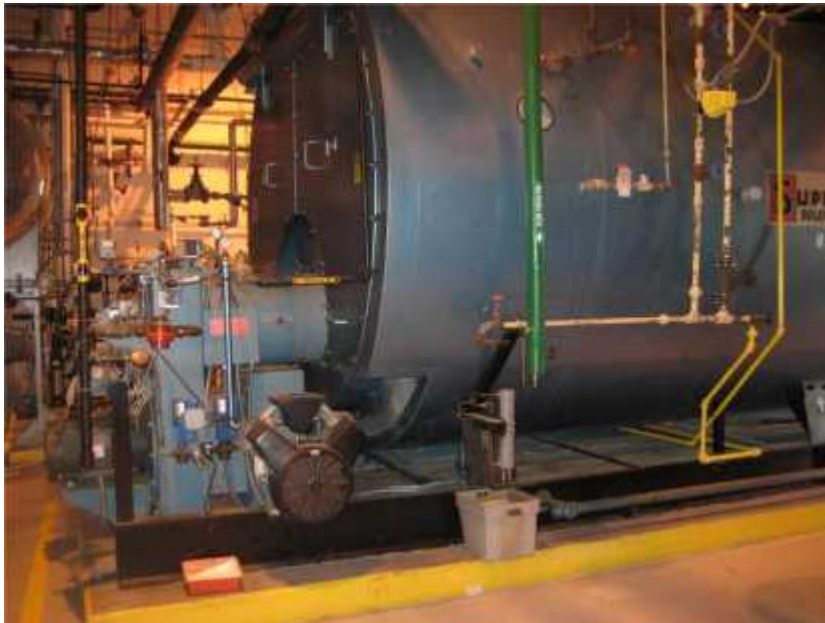
Photo 2. View of boiler. Mechanical equipment supporting critical facilities should be anchored to its foundation in compliance with the building code.

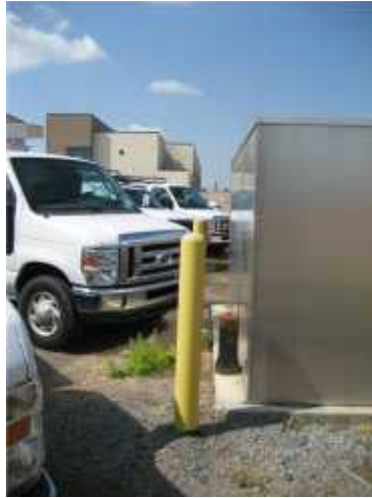
Photo 3. View of potable water backflow preventer on western perimeter subject to vehicle impact.

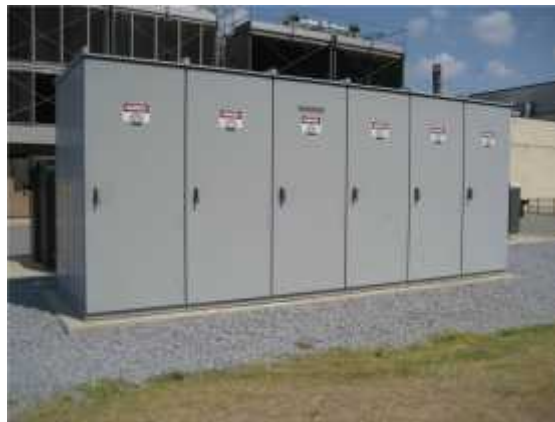
Photo 4. View of electrical switchgear susceptible to vehicle impact along the southern perimeter.

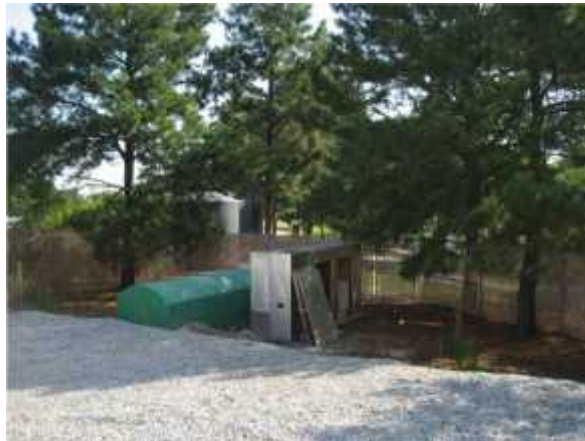
Photo 5. View of trees surrounding the well pumps.

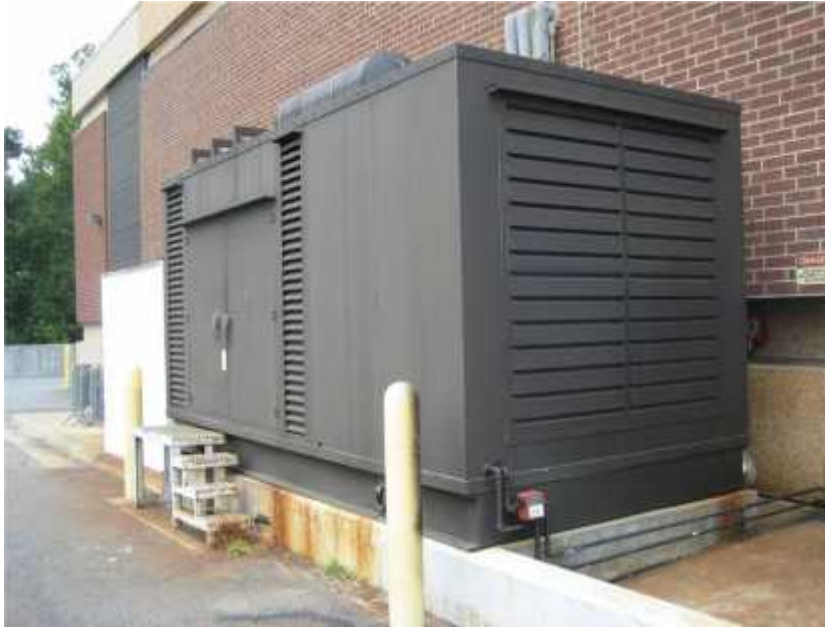
Photo 1. View of the emergency generator at the rear of the facility. Mechanical equipment should be anchored to its foundation in accordance with the building code.

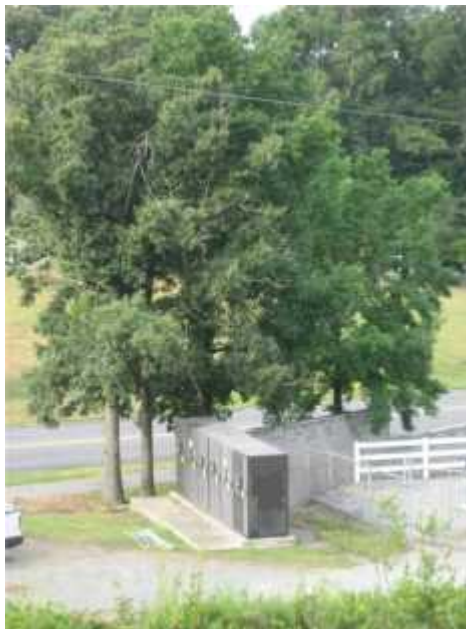
Photo 2. View of the Greenville Utility Company switchgear adjacent to peaking generators. Trees overhanging critical equipment should be routinely pruned and inspected by an arborist.

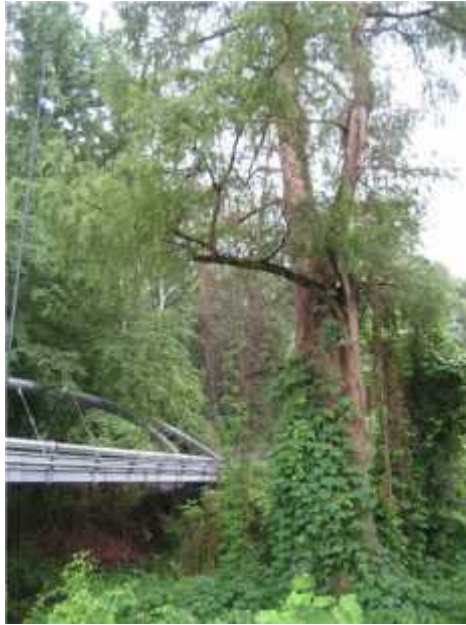
Photo 3. View of large trees overhanging the Greenville Run utility crossing. These trees should be removed as this utility corridor is essential in supplying the main campus with power and heat.

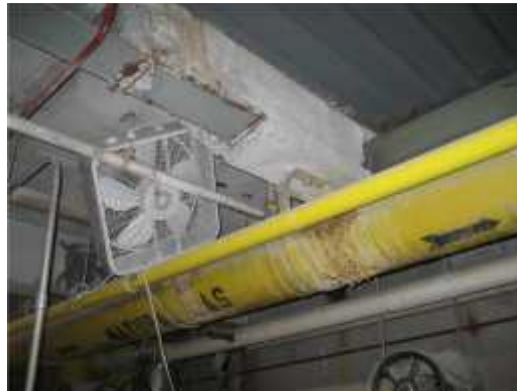
Photo 4. View of deteriorating concrete encasement in basement of steam plant. The concrete should be removed and the corrosion damage to the natural gas line repaired.

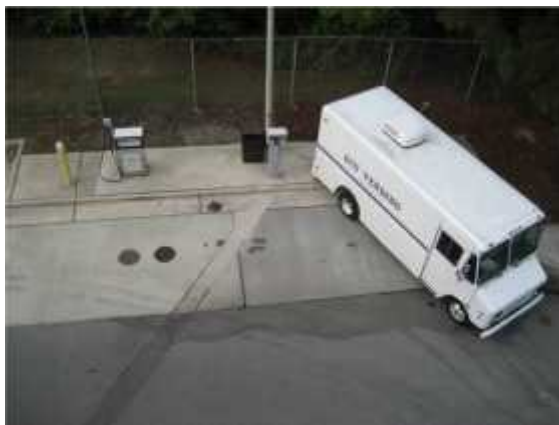
Photo 5. View of fuel pumps exposed to vehicle impacts.

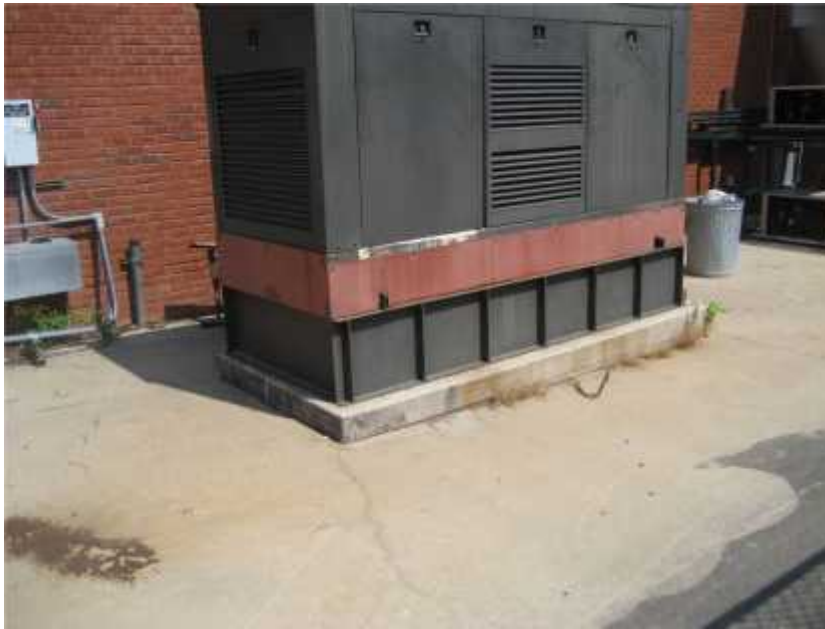
Photo 1. View of the life safety generator. The generator should be properly anchored to its foundation.

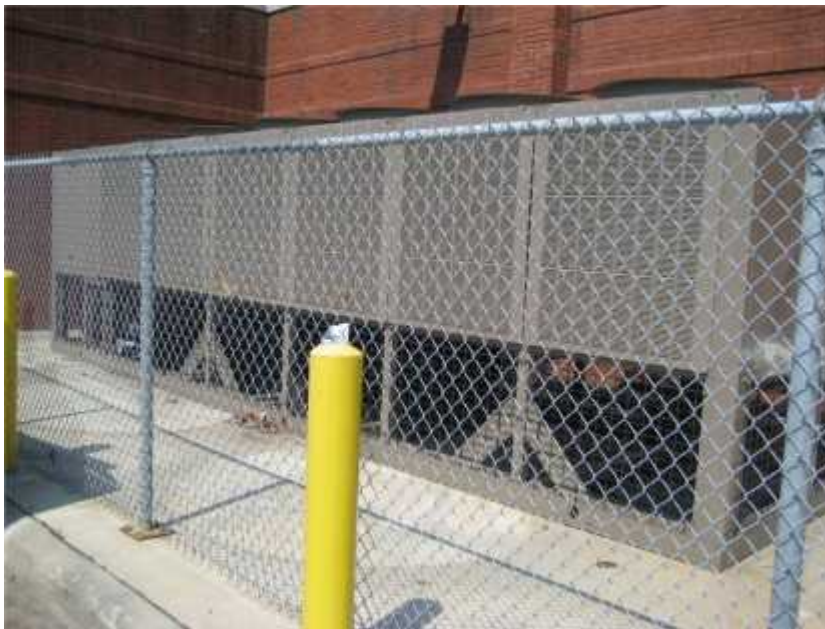
Photo 2. View of chiller unit. The chiller should be properly anchored to its foundation.

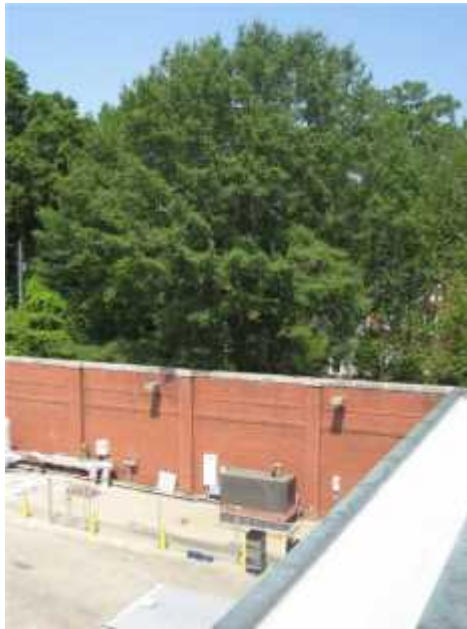
Photo 3. View of large tree adjacent to emergency generator and chiller. The tree should be regularly pruned and inspected by an arborist to decrease the likelihood of wind related damage.

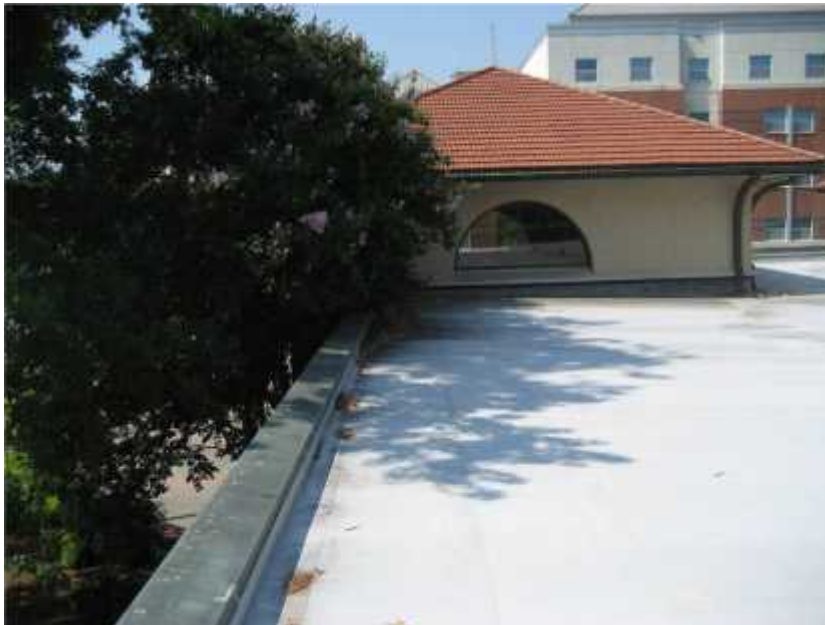
Photo 4. View of trees beginning to grow over roof. Trees should be pruned away from the facility to reduce the amount of drain clogging debris they deposit.
