Water Quality Assessment for the Town of Caswell Beach, 2008

UNCW-CMS Report 08-02

December, 2008

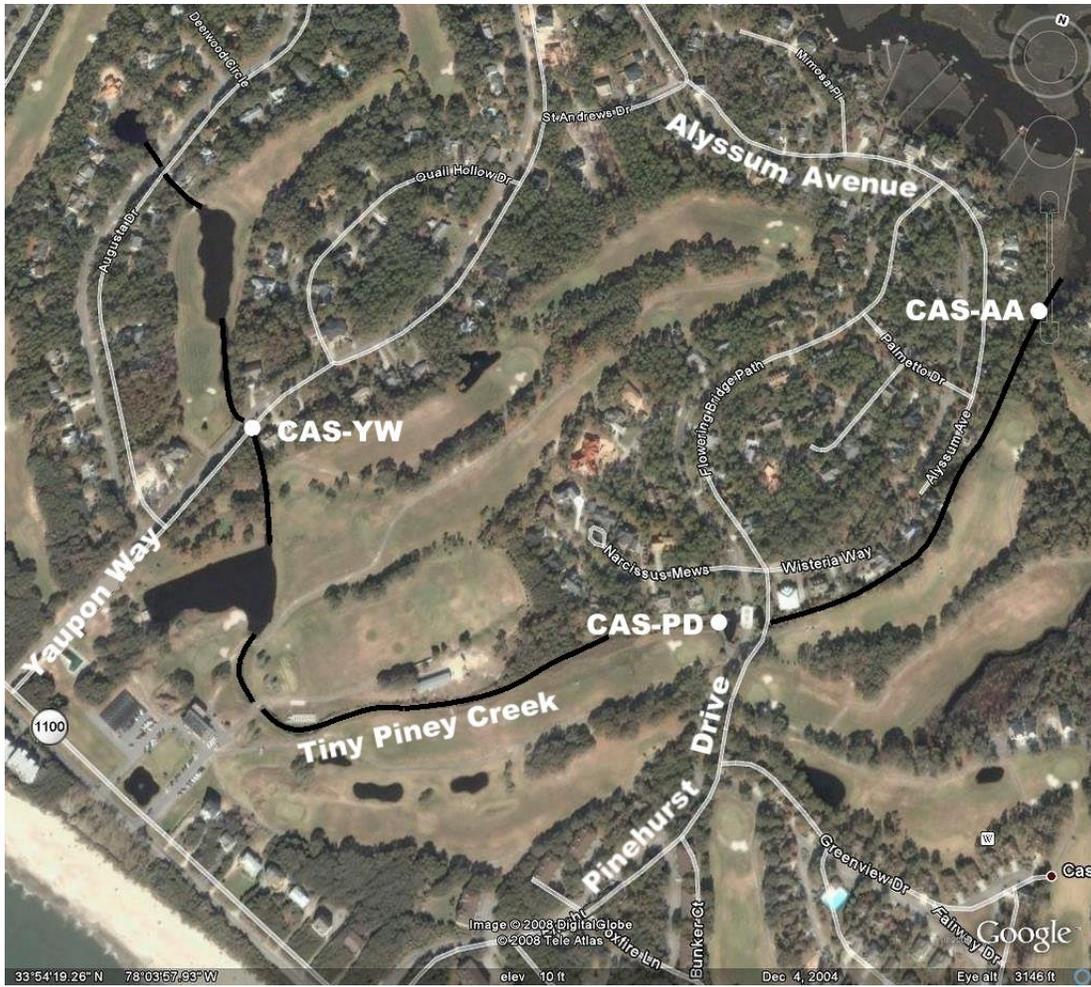
Figure 1. Location of UNCW sampling stations along Tiny Piney Creek in Caswell Beach (path of the stream is enhanced by darkened line).

The investigation involved sampling three locations on three occasions in Tiny Piney Creek during 2008 (Figure 1). Samples were collected January 15, July 23, and October 27, 2008. Station CAS-YW is a system inflow site and was collected in the creek at Yaupon Way where the water leaves a golf course pond (Plate 1). The second site, CAS-PD, was in the middle of a developed area on Pinehurst Drive where the creek passes under a bridge near a spray aerator (Plate 2). The third site, CAS-AA, was accessed from residential yards along Alyssum Avenue and located in the salt marsh in the creek where it leaves the development to enter the estuary, but before it enters Piney Point Creek (Plate 3). GPS coordinates of the stations are in Table 1.

The upper end of Tiny Piney Creek (Figure 1) should be sampled for dissolved oxygen concentrations to see if there are groundwater springs contributing water with low dissolved oxygen to the creek and estuary. The Town can then decide what action, if any, can or should be taken. Since nitrate concentrations are high, the Town can determine if it originates from groundwater sources in the upper creek or is solely from golf course runoff; the answer to this can guide any further action. Since phosphate concentrations are low in the creek, continued efforts to pick up pet waste will help ensure that algal blooms in the creek are kept to a minimum.

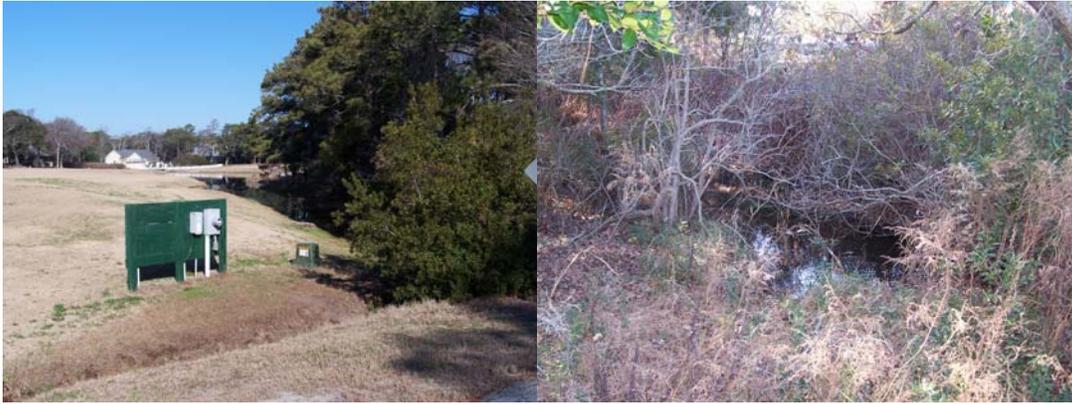
Plate 1. Left – Pond and stream leading into station CAS-YW (right).

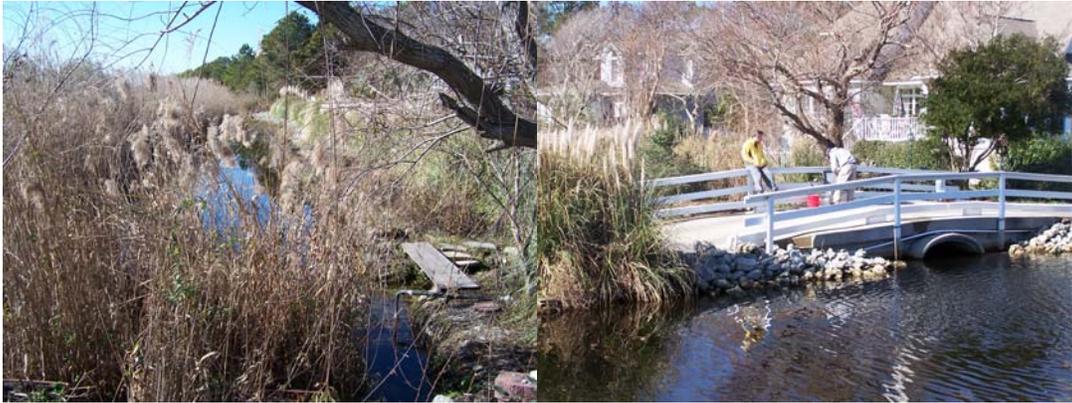
Plate 2. Left - Tiny Piney Creek leading into Station CAS-PD (right).

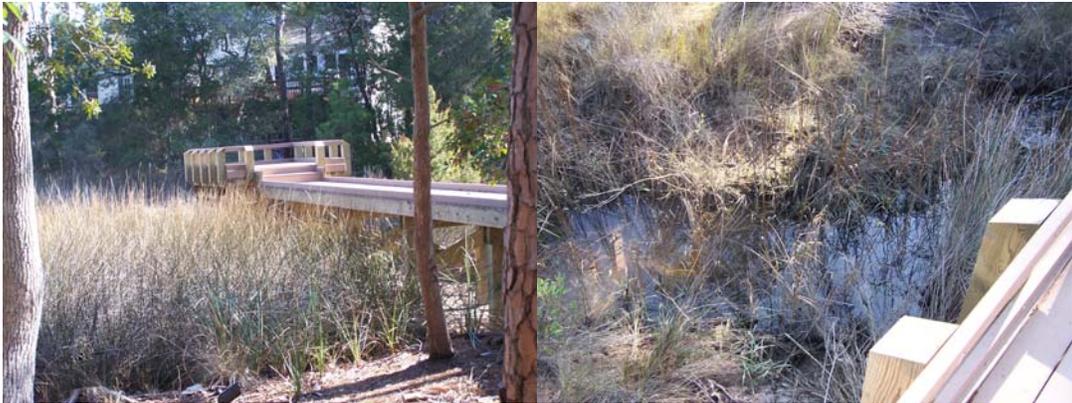
Plate 3. Left -Dock near Station CAS-AA, in upper estuary (right).

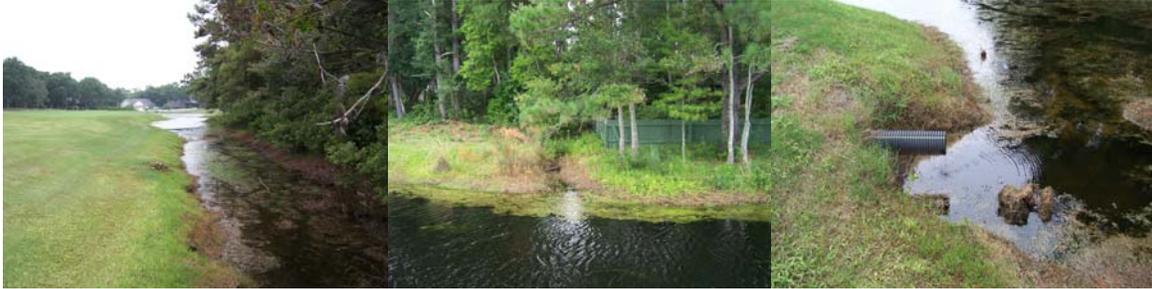
Plate 4. Golf course pond upstream of CAS-YW (left), intermittent stream entering pond upstream of CAS-YW (middle), stormwater drain entering pond upstream of CAS-YW (right).

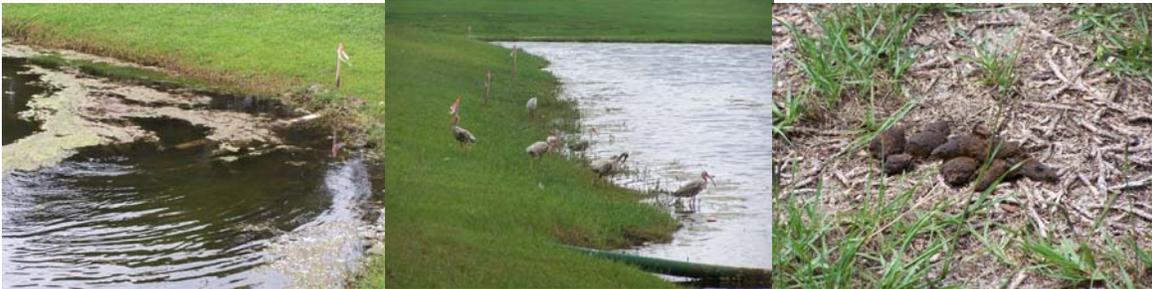
The creek has a problem with high fecal bacteria counts, and solutions to such a problem may be complex. High fecal bacteria counts can be caused by incomplete treatment in septic systems, which is a common problem in coastal areas that have sandy soils and a high water table. If there are any remaining septic systems near the upper creek this could be an issue. We understand the golf course is hooked up to the Oak Island system and their sewage is piped away. The development adjoining the golf course has its sewage treated by a package plant. If the plant malfunctions on occasion high fecal counts can result. Otherwise, leaking sewer lines and pump stations can be problematic in areas where waste is piped elsewhere for treatment (this has been a frequent recent occurrence in Wilmington). In situations where septic or sewer problems are not occurring, elevated fecal bacteria counts in water bodies can result from stormwater runoff. Potential stormwater drainages were observed and photographed along the upper golf course pond above Yaupon Way (Plate 4) and in the pond just downstream of Yaupon Way (Plate 5). Pet manure on the landscape, as well as manure deposited by urban wildlife can create reservoirs for fecal bacteria that are released into nearby streams when rainfall occurs. Dog manure and manure from bird flocks was observed along the pond downstream of Yaupon Way (Plate 5) and wild animal feces near the creek in the estuary by CAS-AA.

Plate 5. Drainage pipe entering pond below CAS-YW (left), Ibis (and ibis manure) along pond below CAS-YW (middle), dog manure along shore of pond below CAS-YW (right).

The most pressing issue is the high fecal bacteria counts in Tiny Piney Creek, throughout its length. We do recommend that the town investigate the sources of this contamination. The UNCW Center for Marine Science is currently performing fecal bacteria source tracking for New Hanover County and the Town of Wrightsville Beach, and would be pleased to assist the Town of Caswell Beach in such an endeavor.
