Eagle Point Golf Course Stormwater Assessment UNCW-CMS Report 09-05

To
New Hanover County Planning Department
North Carolina Coastal Federation
Eagle Point Golf Course
North Carolina State University

September, 2009

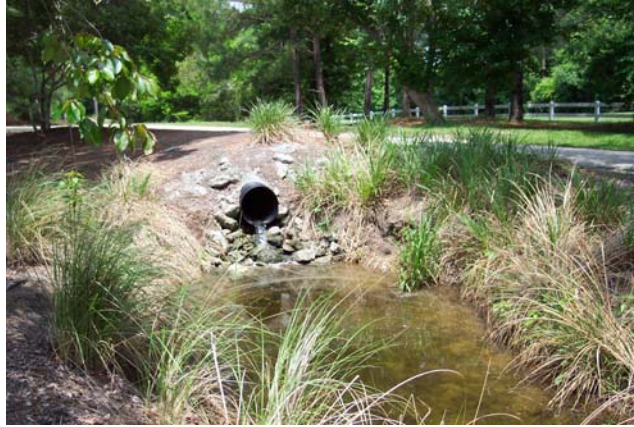
Plate 1. Course input site EP-PNRIN; Porters Neck Road beyond white fence in background.

Three inflow areas to the course were sampled. These were EP-PNRIN, a water body on the 4th hole that receives stormwater drainage inflow from an Assisted Living Center located across Porters Neck Road; EP-GATEIN, an area near the main gate of the golf course where stormwater from outside the course (Bald Eagle Lane and possibly some of Porters Neck Road) collects; and EP-FMIN, a stream site on the 6th hole where a force main delivers off-site water into the course. Two outflow areas were sampled on the course. These were EP-BROUT, the headwaters of Little Creek on the course sampled from a small footbridge under the entrance road to the course; and EP-OUT18, a low area adjacent to the 18th hole where drainage enters into the marsh bordering upper Little Creek. One pond on the course was sampled, the pond on the par 3 course was sampled from a bridge crossing the pond. Finally, one station was sampled in Little Creek proper from a dock in the backyard of a friendly property owner on 8101 Bald Eagle Lane (EP-LC). Samples were collected on the following dates: January 28, March 3, March 17, April 24, May 28, and June 17. We note that the June sample differed from the others because work had already commenced on a constructed wetland upstream of EP-BROUT and a lightning strike had affected a pump on the course as well. The EP-GATEIN site was dry on the dates of the January and April samplings.

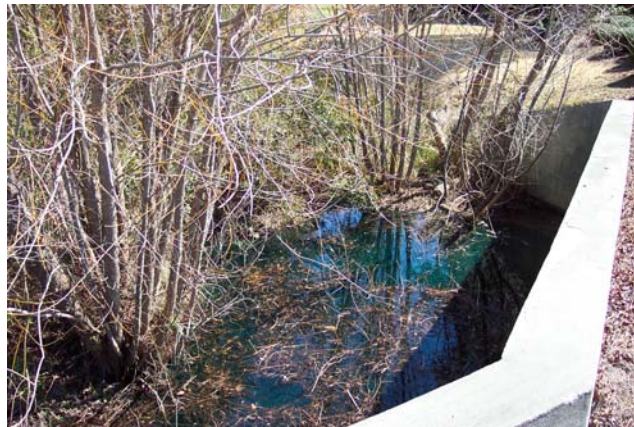
Plate 2. Course stormwater input site EP-GATEIN near main gate.

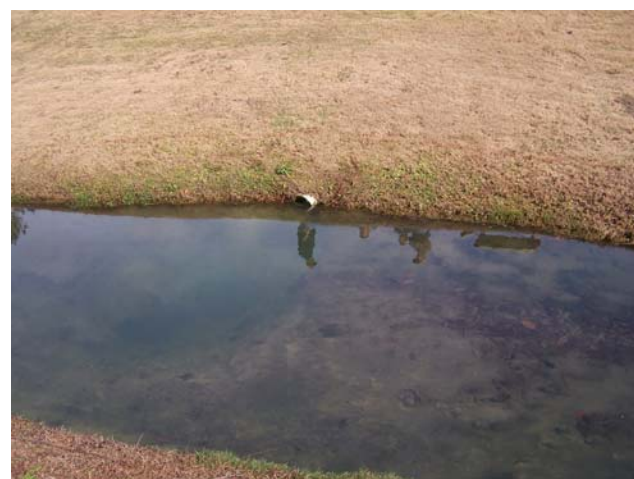
Plate 3. Course input site EP-FM, force main input.

Inputs from the force main contained generally low fecal coliform bacteria counts, and low nitrate and orthophosphate concentrations. Other than on one occasion, turbidity and TSS were also low where this input enters the creek on-course. Thus, the data indicate that inputs from the force main are not problematic to Eagle Point Golf Course or Little Creek; rather, surface inputs (from stormwater runoff) are the problem.

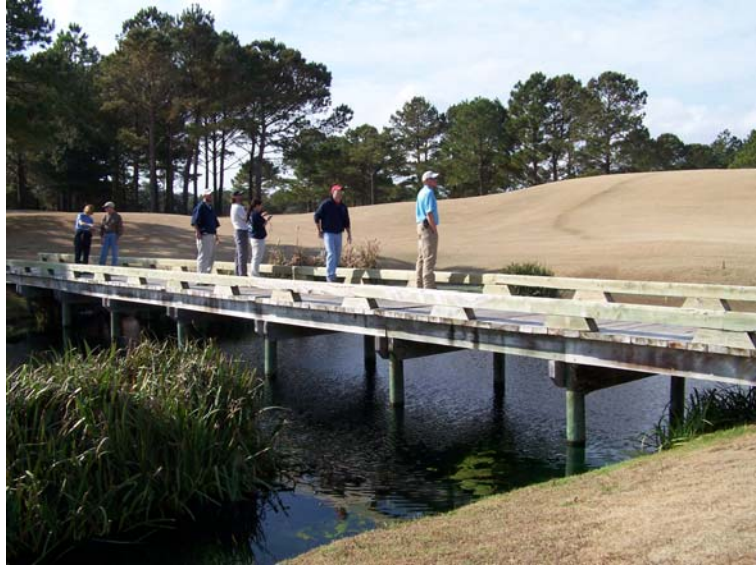
Plate 4. Sampling site on pond on par 3 course EP-POND3, from bridge.

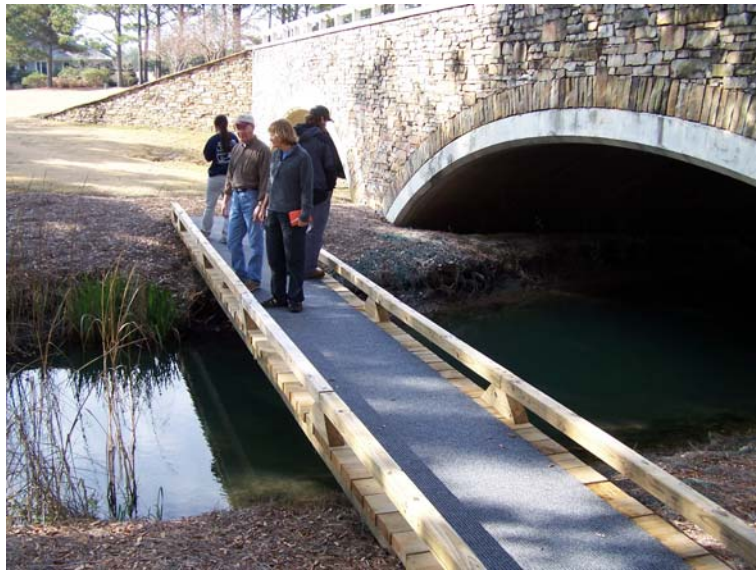
Plate 5. Course outflow site from small bridge, EP-BROUT.

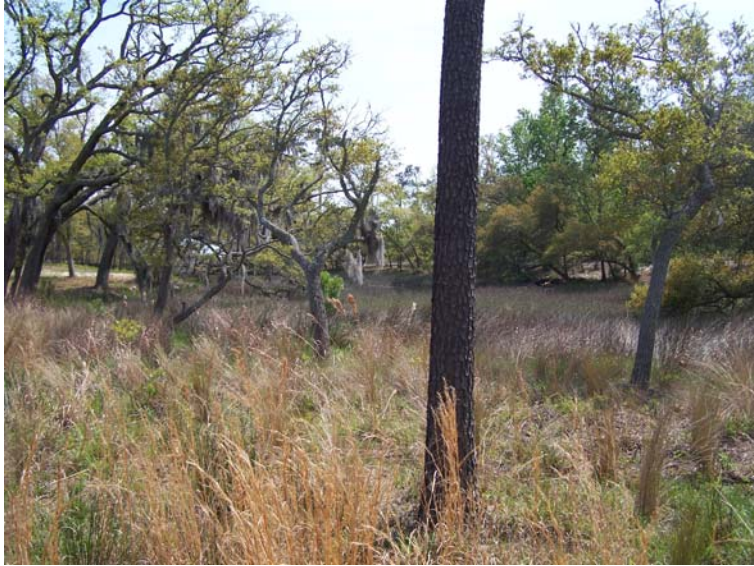
Plate 6. Course outflow site between holes 1 and 18 in low area, EP-OUT18.

Salinity: Four of the sites were freshwater throughout the study. One of the outflowing sites, EP-OUT18, was oligohaline with a mean salinity of 1.1 psu (practical salinity units), ranging from 0.6-1.4 psu. The Little Creek site was euhaline with a mean salinity of 31.4 psu ranging from 25.4-34.8 psu.

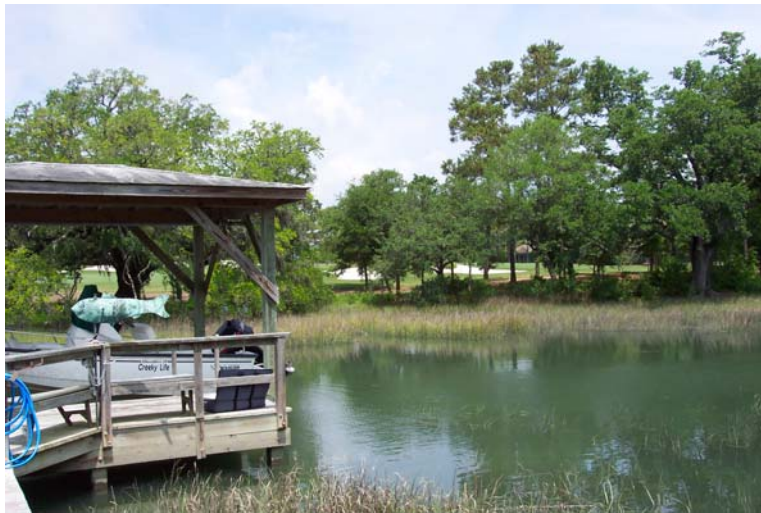
Plate 7. Little Creek sampling site from Winterbauer property EP-LC, with Eagle Point golf Course in background across creek.

Twice (March and June) there were counts in Little Creek (EP-LC) that exceeded the human contact standard of 200 CFU/100 mL, and in April the counts exceeded the shellfishing standard (although counts on the course were not particularly high in April - Table 8). For similar salinity ranges, the geometric mean fecal coliform counts in Little Creek were greater than those of other area tidal creeks (Mallin et al. 2000) although we note that elevated salinities persist farther upstream in Little Creek compared with those other creeks (and closer to inland sources). The data indicate that the fecal coliform counts in our study do not bode well for continued open-status for shellfishing in this creek. In a four-month study from April-July 2001 our laboratory found considerably lower fecal coliform bacteria counts in all three areas of Little Creek that were sampled (Mallin et al. 2002b). Thus, based on limited data, fecal bacteria counts in this creek may be increasing along with increasing urbanization in this area.

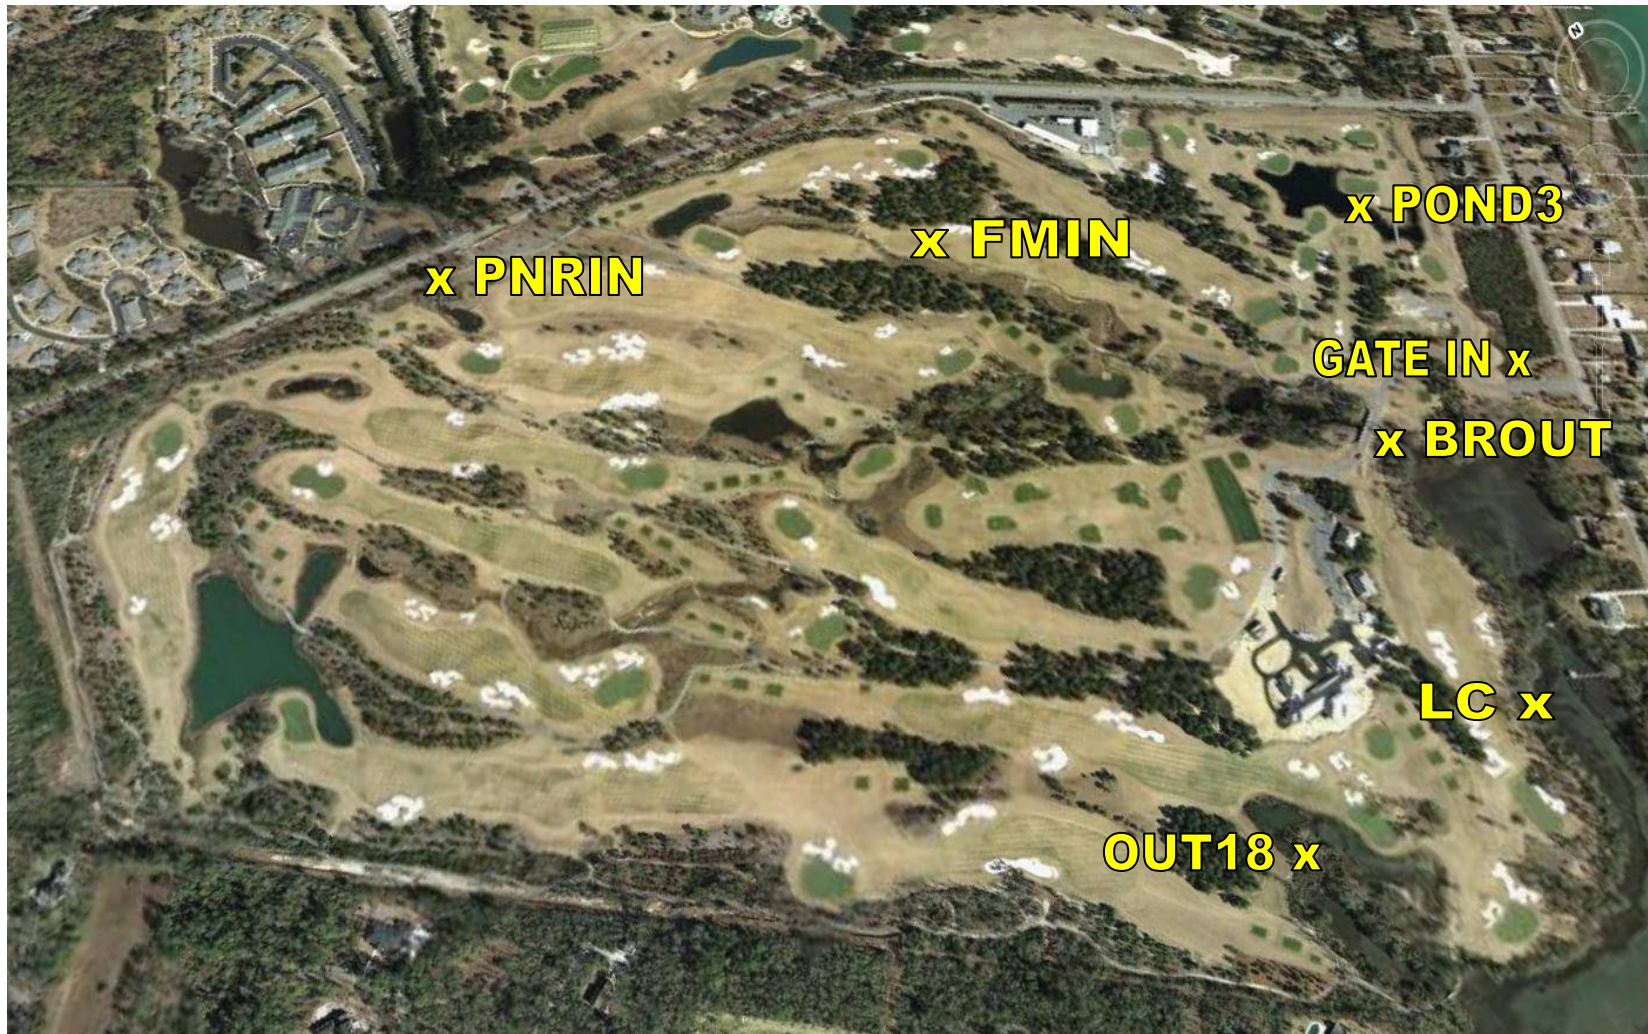
Figure 1. Map of Eagle Point Golf Course showing water quality sampling sites. Porter's Neck Road is near the top of the map and Bald Eagle Lane is to the right, bordering Little Creek.

In 2003, Eagle Point Golf Course (Figure 1) entered ~218 acres of the 231.5 acre site into a conservation easement agreement with the North Carolina Coastal Federation, to ensure that the property would be retained in perpetuity in a predominantly natural, scenic and open space condition. In addition to preserving conservation values, Eagle Point provides important functions as a riparian buffer for the adjacent Little Creek and Middle Sound estuary, as the course is situated between intense urban development and an extremely fragile and valuable estuary. Although conservation measures taken by Eagle Point Golf Course have greatly minimized its stormwater runoff contribution to adjacent Little Creek, the course receives and absorbs significant off-site stormwater runoff from offsite sources such as the heavily-developed Porters Neck development and Golf Course, as well as from additional newly-constructed roadways and rapidly-increasing development found upstream from Eagle Point Golf Course. UNCW's 2001 water quality sampling of Little Creek (Mallin et al. 2002a) yielded mostly positive results, indicated in the following excerpts: "...Little Creek is a high-salinity system with few water quality problems." and "Thus, based on limited data, Little Creek was in generally good condition, although there is potential for occasional fecal bacterial contamination." However, since the 2001 sampling, upstream development has increased dramatically, and both Eagle Point Golf Course owners and area residents have expressed greater concerns about the water quality impacts associated with the increase in polluted stormwater runoff, and the inability of the existing on-site stormwater management systems to protect Little Creek and Middle Sound estuary.

The water quality research for this mini-grant was performed between January and July of 2009. Water quality sampling performed by UNCW included water temperature, conductivity/salinity, pH, dissolved oxygen, and turbidity, all by use of YSI field instrumentation. Water samples were collected on site by hand for fecal coliform bacteria, total suspended solids (TSS), chlorophyll *a*, nitrate, total nitrogen, orthophosphate, and total phosphorus determination. Laboratory analyses were performed utilizing Standard Methods (APHA 1995) and EPA procedures (USEPA 1997; Welschmeyer 1994). Samples were collected at seven stations from areas where stormwater enters the course, critical areas on the course impacted by stormwater (i.e., the creek on course), and the receiving creek off-site (Table 1; Figure 1).
